## Initial observations of the 11 June 2012 rock/ice avalanche, Lituya Mountain, Alaska

**Abstract** On 11 June 2012, a large volume of rock and ice collapsed on the eastern flank of Lituya Mountain, Alaska (approximately 58° 48' N; 137° 26' W). The displaced mass fragmented as it travelled 2.5 km down the steep (35-40°) eastern flank of the mountain. The landslide flowed for another 6.5 km over a tributary of John Hopkins Glacier. The total elevation drop is estimated at 2.5 km and the total travel distance was 9 km, yielding a travel angle of 15.5°. The areal extent of the landslide is 7-8 km<sup>2</sup>. The landslide generated a significant air blast which travelled in a straighter trajectory than the landslide, and resulted in an airborne deposit more than 500 m above the rock avalanche debris. The landslide triggered seismic signals of 3.4 and 3.7 M, as interpreted by US and Canadian earthquake agencies, respectively.

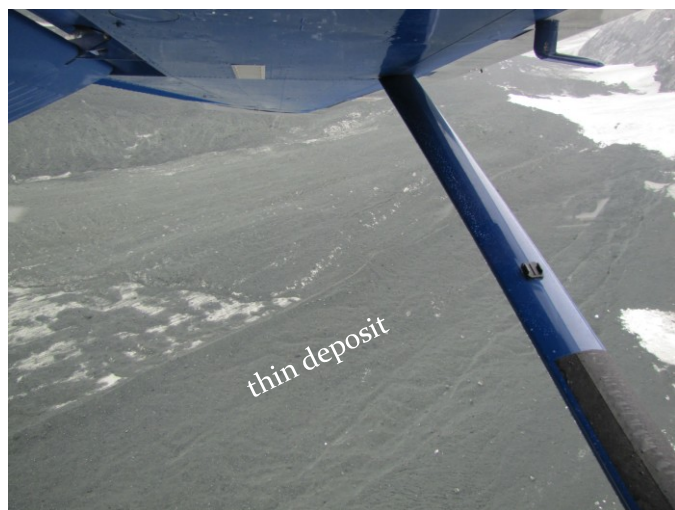
Figure 6 Thin debris cover on the glacier. Note bare ice patches. Also note post-landslide snow avalanches (right margin of photo). Original photo by Drake Olson.

I could not calculate the volume loss in the zone of depletion, nor the thickness of the deposit on the glacier from the available data. If one assumes most of the debris was deposited on approximately 5-6 km<sup>2</sup> of glacier, average thicknesses of 1 to 10 m would yield volumes of 5 million to 60 million m<sup>3</sup>. The average debris thickness of similar landslides (triggered by the Denali Earthquake in 2002) was 3 m (Jibson et al, 2006). Such a thickness could yield a volume of up to 18 million m<sup>3</sup>. From Drake Olson's photos it is clear that the deposit varied in thickness, with bare glacial surfaces evident in the thinner zones (Fig. 6), and considerably thicker deposits elsewhere (Fig. 7). Detailed calibrated stereographic

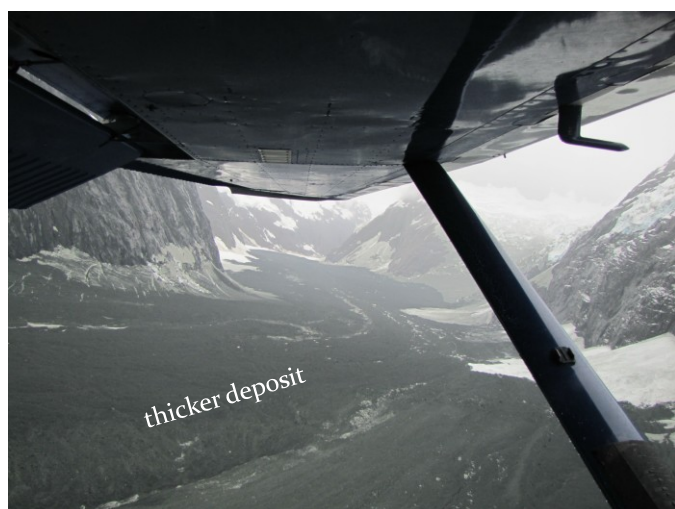
Figure 7 Thicker debris on the glacier. Original photo by Drake Olson.
